FRONTLINE

Property Inspection Report
Prepared for:

**1487 Leslie Rd.
Clearwater, FL 31313**

Date Inspected:
12/31/2011

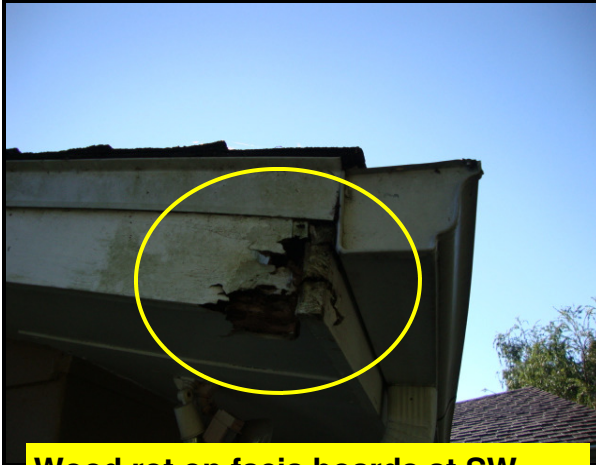
- D. Some step cracks noted on the NE corner of the home. These cracks are the result of minor settlement. Keeping all cracks properly sealed will limit water penetration.
- E. Damaged fascia/soffit boards noted at SW corner of the home. I recommend that all damaged wood be replaced.
- F. The gutters on the north side of the home are completely full of debris and should be cleaned out to prevent damage to the roof. Also, there is a sag in the gutter near the east side over the front entry. The gutter should be repositioned and secured to allow for proper drainage.
- I. Some small gaps noted around exterior window frames, window sills, hose bibs, etc. These should be sealed up to prevent water penetration and should be checked annually as part of a preventative maintenance program.

Wood rot on fascia boards at SW corner of home (page 2, E.)

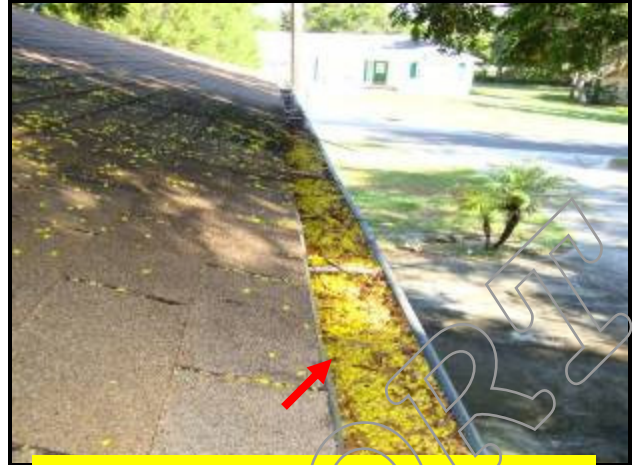
Gutters full and causing anchors to pull away from home (page 2, F.)

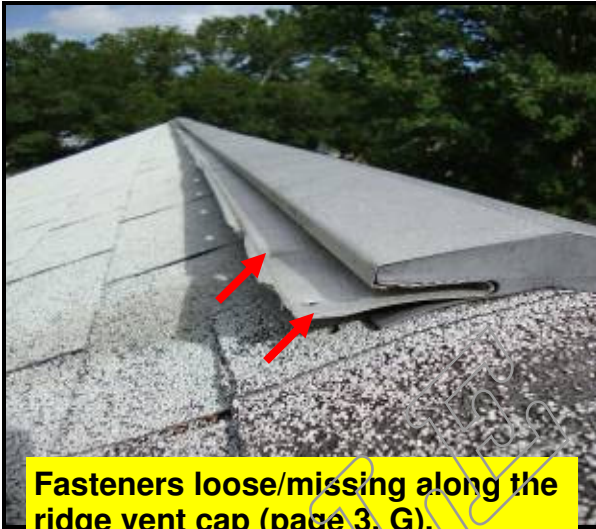
G. Some fasteners are loose and missing along the edges of the ridge vent cover and there are some small gaps around several fastener heads. I recommend that these fasteners be sealed to prevent potential water leaks into the attic.

Fasteners loose/missing along the ridge vent cap (page 3, G).

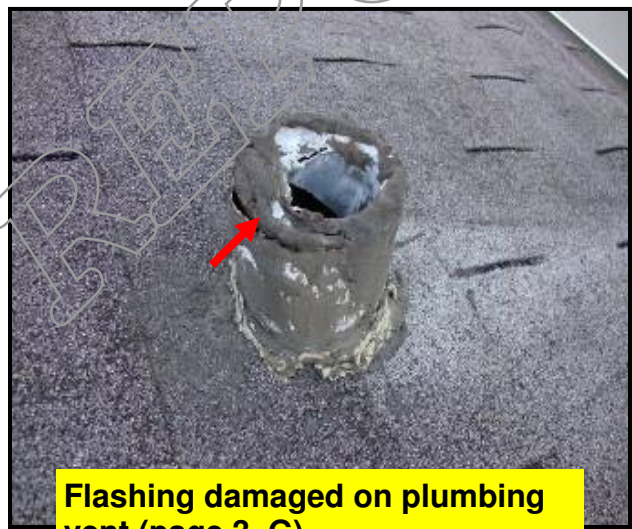
G. The lead boots over plumbing vent pipes are damaged at top. Minor leaking could result. The boots need to be replaced or repaired.

Flashing damaged on plumbing vent (page 3, G).

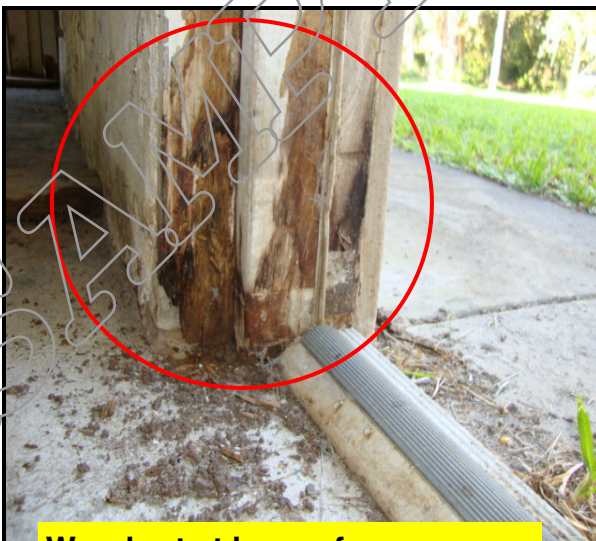
G. The service door jamb has damaged wood at bottom corners. It is recommended that all damaged wood be replaced.

Wood rot at base of garage service door jamb (page 3, G).

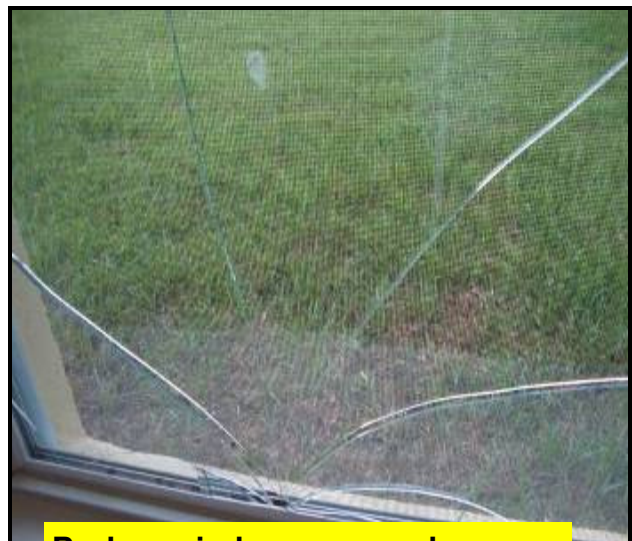
J. The lower glass pane is broken in the single hung window and will need to be replaced.

Broken window pane on lower sash - garage window (page 3, J).

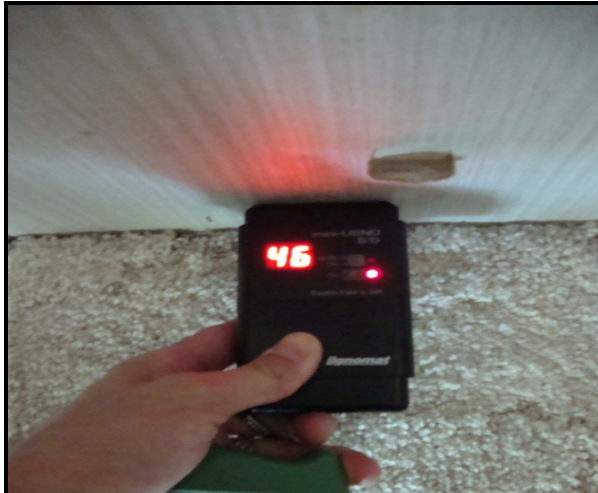
- A. Stains noted on ceiling, above the fireplace and SE corner of the master bedroom. The homeowners report that these are from prior roof leaks. Testing with an electronic moisture meter in the areas show elevated levels of moisture indicating the leaks are active. I recommend that you have a licensed roofing contractor evaluate the roof and make necessary repairs to stop the roof leaks.

Elevated moisture in wall at SE corner of master bedroom (page 4, A).

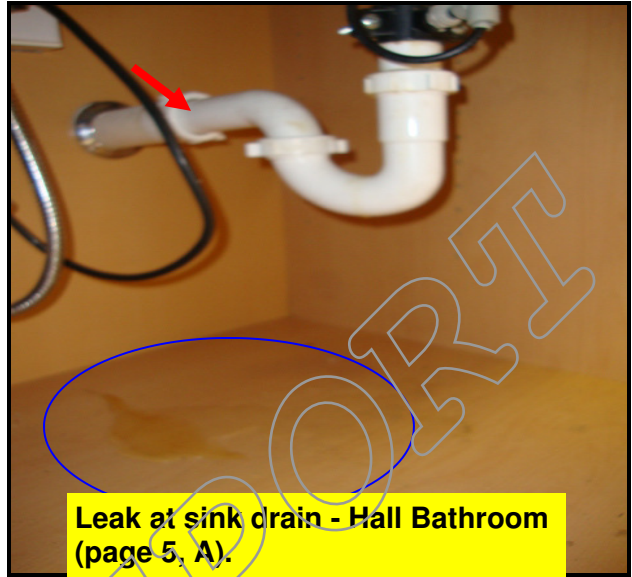
- A. Leak noted at sink drain pipe. Repairs needed.
- E. I could not get the ceiling exhaust fan to work. The fan is getting power, but the blades do not turn.

Leak at sink drain - Hall Bathroom (page 5, A).

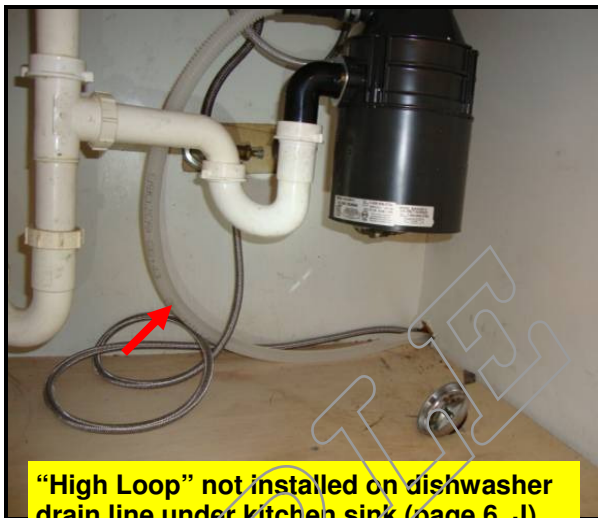
J. A "High Loop" should be installed on the dishwasher drain line where it meets sink drain line to prevent sink drain water from flowing into the dishwasher.

"High Loop" not installed on dishwasher drain line under kitchen sink (page 6, J).

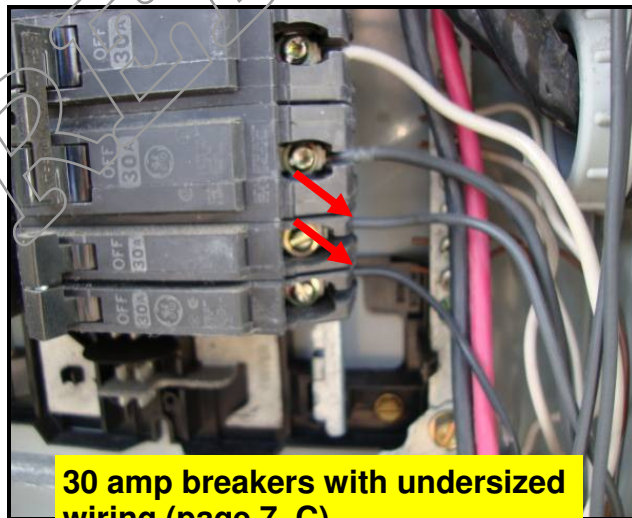
- B. Each of the breakers are not clearly labeled. All breakers should be labeled for future reference.
 C. The 30-amp breakers, labeled "Lanai 1 & 2," have 12 gauge wires attached to it. This breaker is too large for the supply wire. This size wire should have a 20-amp breaker.
 D. Exposed wire connections and missing junction box covers noted in the attic. All wire connections should be enclosed in sealed electrical box for safety.
 G. GFI outlets are in working condition. They are located in the kitchen, bathrooms, garage and exterior. It is recommended that GFI test buttons be depressed at least once a month to verify that outlets are in working order.
 H. I recommend that a licensed electrician check the electrical system, including items noted above, and make needed corrections.

30 amp breakers with undersized wiring (page 7, C).

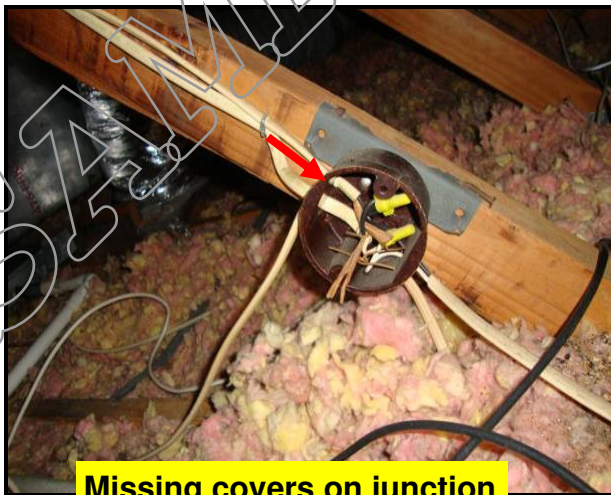
Missing covers on junction box in attic (page 7, D).

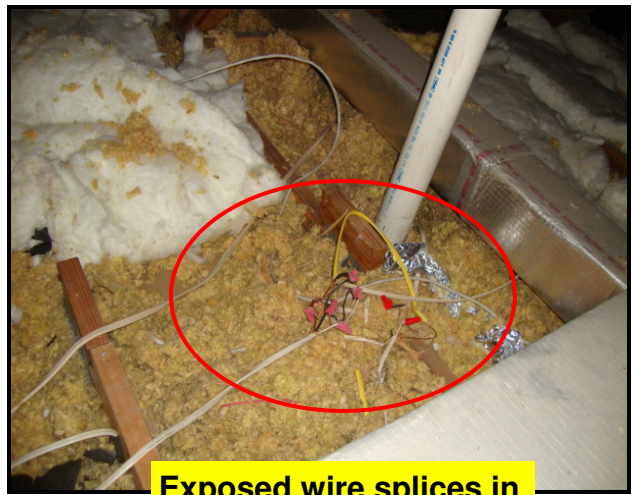
Exposed wire splices in attic (page 7, D).

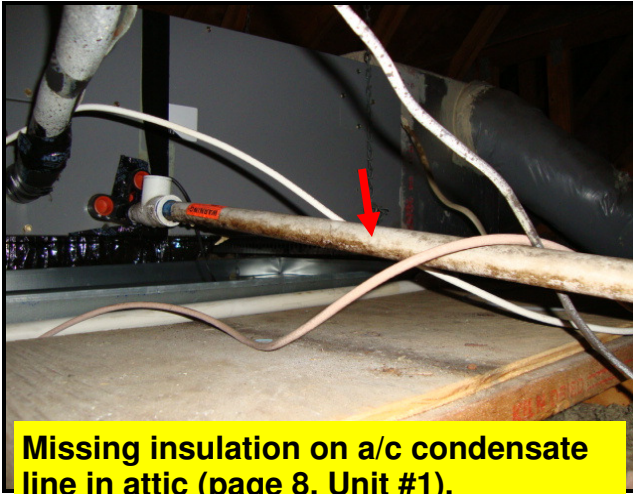
Unit #1. In the attic, the PVC condensate line, which drains water from the air handler to exterior, is not properly insulated. Insulating this drain line will prevent condensation from dripping onto the floor of the attic.

Missing insulation on a/c condensate line in attic (page 8, Unit #1).

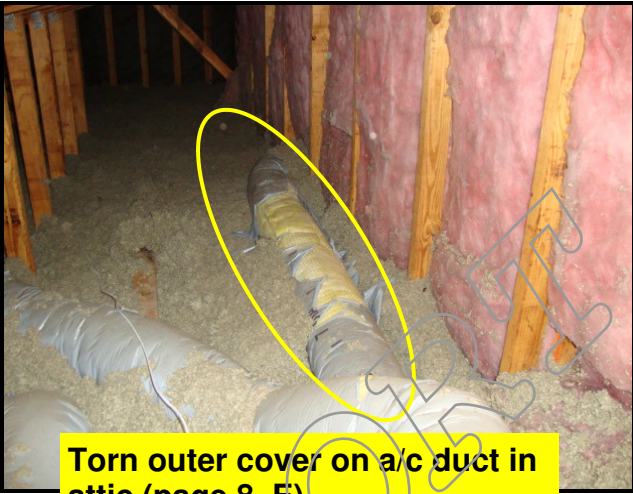
E. A section of flexible cylindrical duct, in the attic, has a torn outer gray plastic cover, exposing the insulation. This section should be replaced or properly repaired by a licensed air conditioning technician.

Torn outer cover on a/c duct in attic (page 8, E).

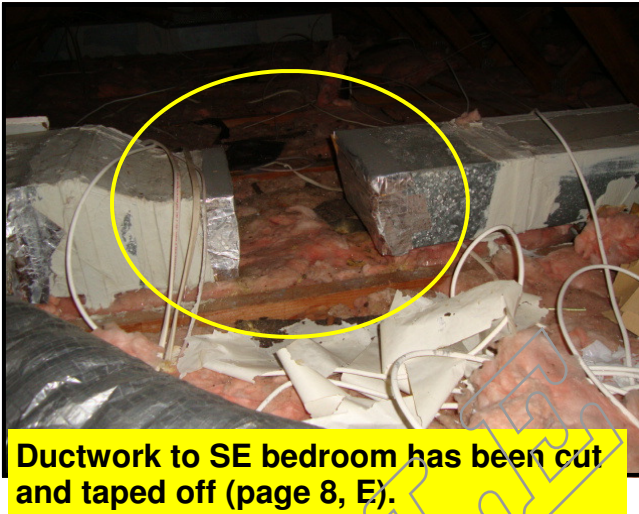
E. A section of ductwork over the SE bedroom has been cut and taped off. Currently, this room does not have an source of heating or cooling. Repairs will be needed to correct this problem.

Ductwork to SE bedroom has been cut and taped off (page 8, E).

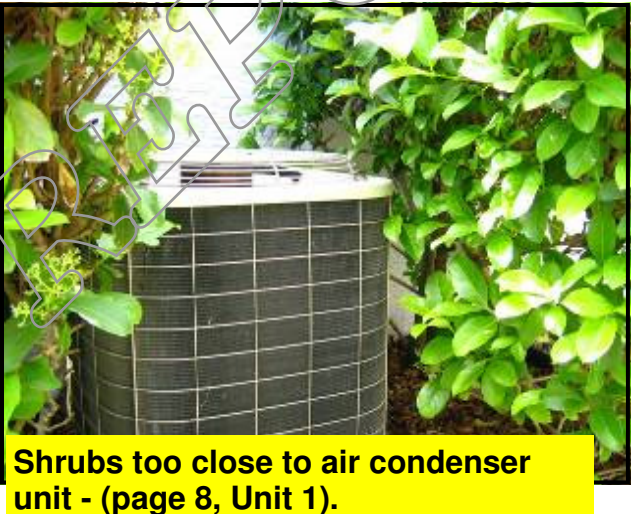
Unit #1. Shrubs should be trimmed at least 3 feet away from condenser unit to allow proper air flow.

Shrubs too close to air condenser unit - (page 8, Unit 1).

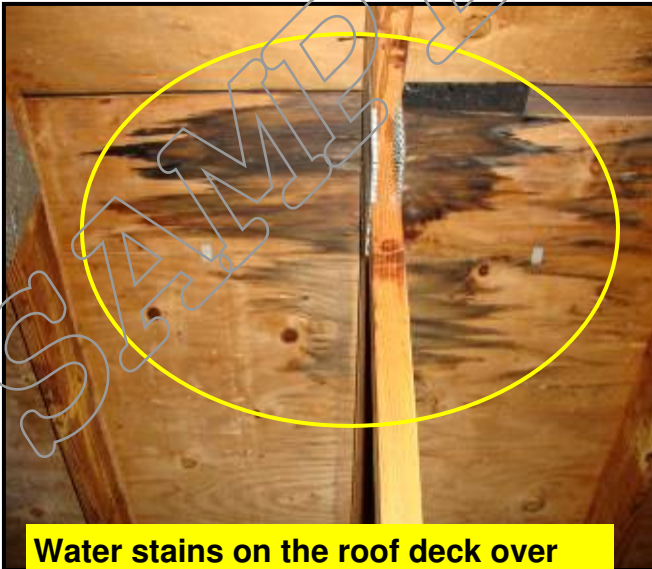
A. Water stains noted in several places at the eaves on inside of fascia boards on the east and west sides of the attic. Also, there is a stain above the air handler at the north side of the home. The stains tested positive for moisture with an electronic moisture meter. I recommend that a licensed roofer evaluate the roof and make any necessary repairs.

Water stains on the roof deck over the air handler (page 9, A).

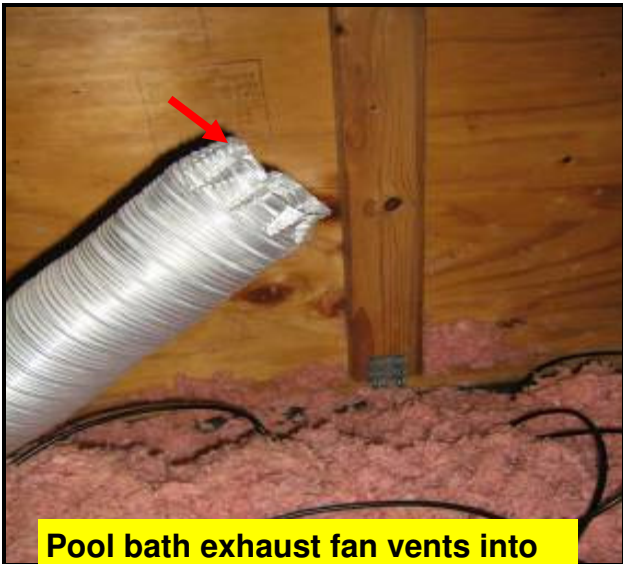
I. The pool bathroom exhaust fan vents into the attic. It is recommended that exhaust fans vent to the exterior to limit moisture build-up in the attic.

Pool bath exhaust fan vents into attic (page 9, I).
